CITY OF ALEXANDRIA
HISTORIC PRESERVATION OFFICE
APPLICATION FOR BAR ADMINISTRATIVE
APPROVAL
APRIL 24, 2018

REPAIRS TO THE HISTORIC MAIN HOUSE
619 S LEE ST.
ALEXANDRIA, VA

BAR2018-00198

January, 10th, 2018

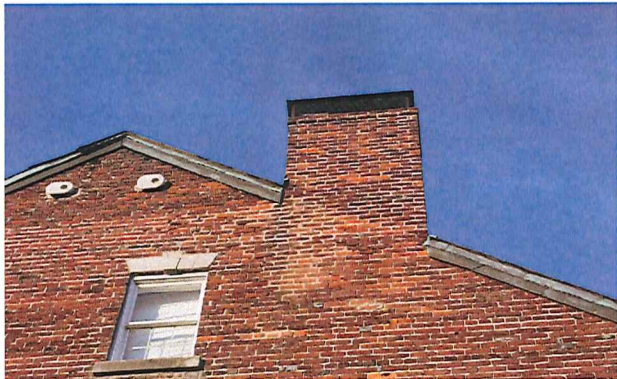
3 NON-HISTORIC COPPER RAKE TRIM
 (TO BE REMOVED)

- f. **Wood Rake, Window and Eave Trim** – Copper trim has been added at the rake of the roof which is believed to be non-historic (HABS photo in package shows wood rake). This application proposes removing the copper trim and replacing with painted wood trim. The wood trim at the window at the third floor on the north elevation is badly deteriorated and is proposed to be replaced to match the existing details. Any wood substrate or other trim that is found to be in need of repair will be replaced in kind to match existing.

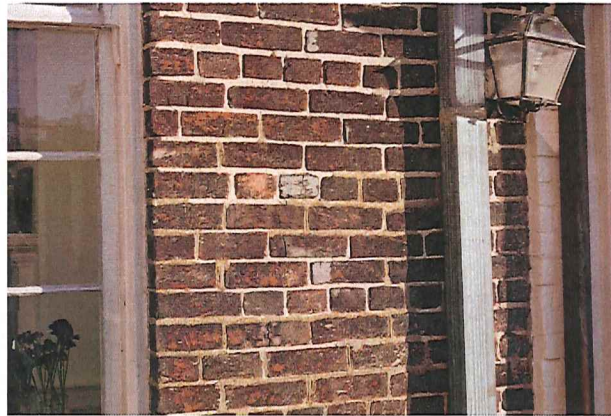
- g. **Mortar Joints** – The mortar joints on the north, west and south elevations show varying degrees of deterioration and inconsistent repairs over time, this application proposes repointing the non-historic joints on those elevations, as directed by Alexandria Preservation staff in the field. The mortar joints on the east elevation are in good shape and no work is proposed. The selected mason will provide an analysis of the existing historic mortar and propose a lime-based mortar to match the original in color, texture and composition. Proposed joint profiles shall match existing historic profiles. Joints will be pointed as necessary behind existing wood brickmould which will remain in place at the masonry openings. Any damage to the existing brickmould will be repaired and all wood trim will be cleaned, caulked and painted as part of this repair scope. Sashes of windows below the roof will not be restored at this time. Windows can be accessed from inside the house for restoration as part of the overall house restoration / additions.

3 WEST ELEVATION - REPOINT JOINTS
NOT TO SCALE

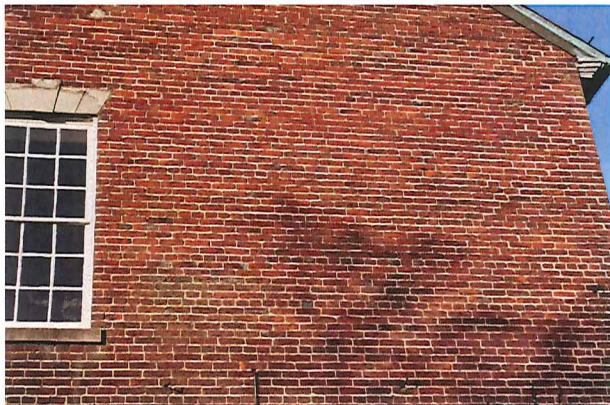
2 SOUTH ELEVATION - REPOINT JOINTS
NOT TO SCALE

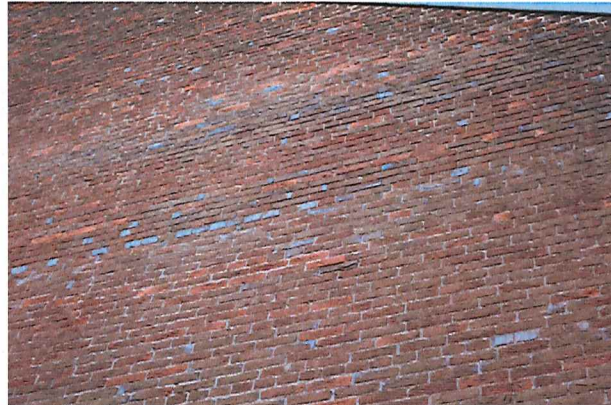
4 NORTH ELEVATION - REPOINT JOINTS
NOT TO SCALE

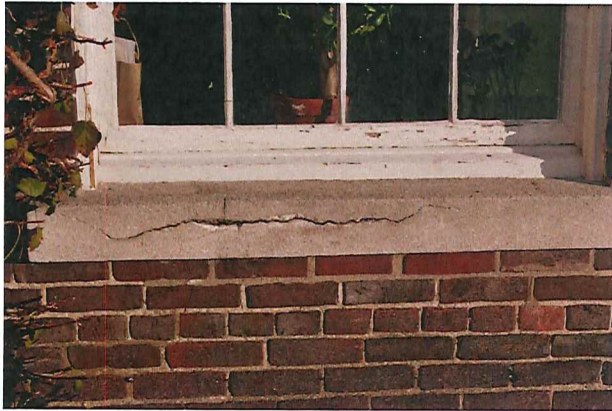
1 CONCRETE SILL - REPLACE
NOT TO SCALE

- h. **Stone Sills and Headers** – This application proposes removing all concrete sills and removing paint from all sills and headers. After paint is removed, stone will be assessed for repair or replacement as confirmed by Alexandria Preservation staff in the field. Existing stone sills and headers (Aquia Creek sandstone) will be repaired in place or removed and replaced with approved stone to match historic profiles, as directed by Alexandria Preservation staff in the field. Mason to provide stone sample for approval prior to removing any material (Pennsylvania sandstone). Mason to provide specifications and application process for stone repair products (Conproco Matrix) for approval prior to commencing with work.

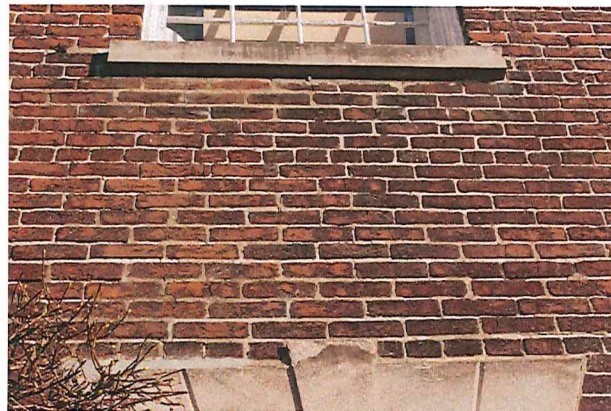
3 DAMAGED HEADER - REPAIR OR REPLACE
NOT TO SCALE

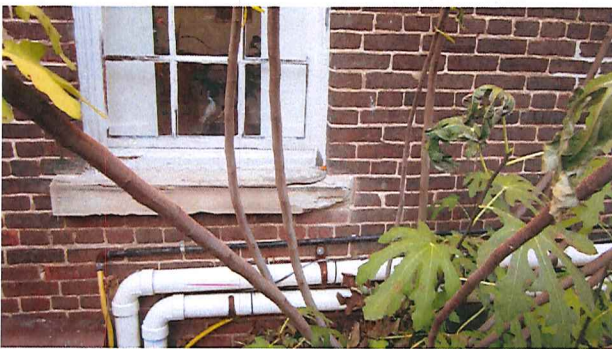
2 DAMAGED STONE SILL - REPAIR OR REPLACE
NOT TO SCALE

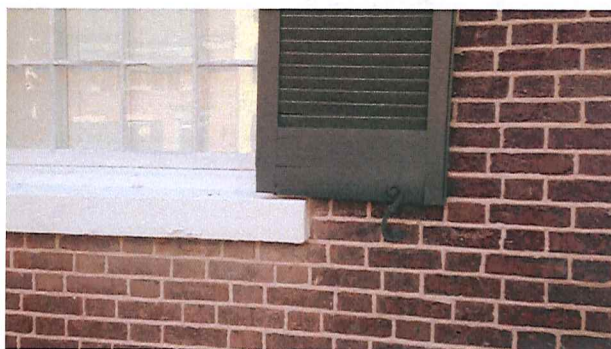
4 PAINTED SILL - REMOVE PAINT, ASSESS NEEDS
NOT TO SCALE

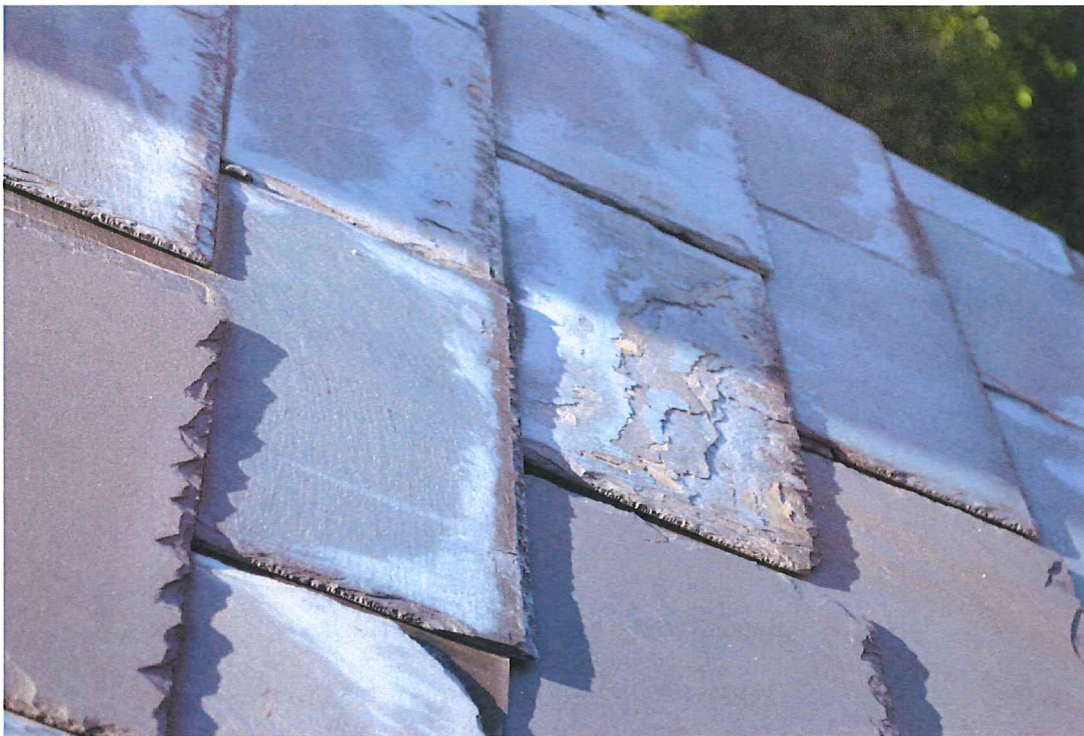
619 S. Lee Street House Roof image 1.

Delamination or Slate Rot

“Delamination is caused by the reaction of certain minerals to long-term moisture cycles. Over time, these minerals expand, causing layers to separate along cleavage planes. Because slates are most likely to absorb moisture along their edges, that’s where delamination is often most obvious. As slate ages, paper-thin flakes separate from its surface, and its interior becomes increasingly soft and spongy as the inner layers also begin to delaminate”.

“As layers delaminate, they provide an avenue for moisture to be absorbed into the tile’s interior. “Rot” is the term most commonly used to describe this delamination. The softening, crumbling effects of slate deteriorated by moisture are similar to wood rot.”

The delamination of the slate also occurs on the underside of the slate as is evident on the removed slate sample I examined. Therefore, the visible damage is not the only damage occurring to the slate at this time.

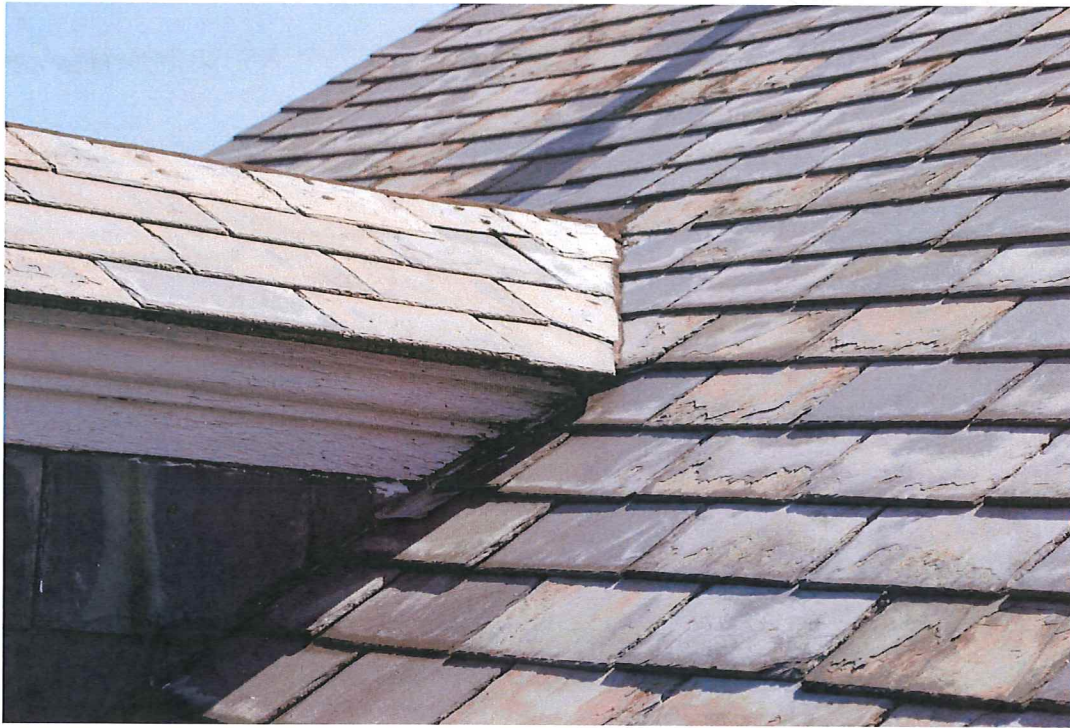
619 S. Lee Street Image 3 & 4.

Along with the, Slate Rot, I found numerous areas where the roofing nails have “pushed” their way thru the slate above to expose the nail head and in doing so are providing water access to the roof deck below. In addition this roof has also been the recipient of multiple poorly executed repairs over the years.

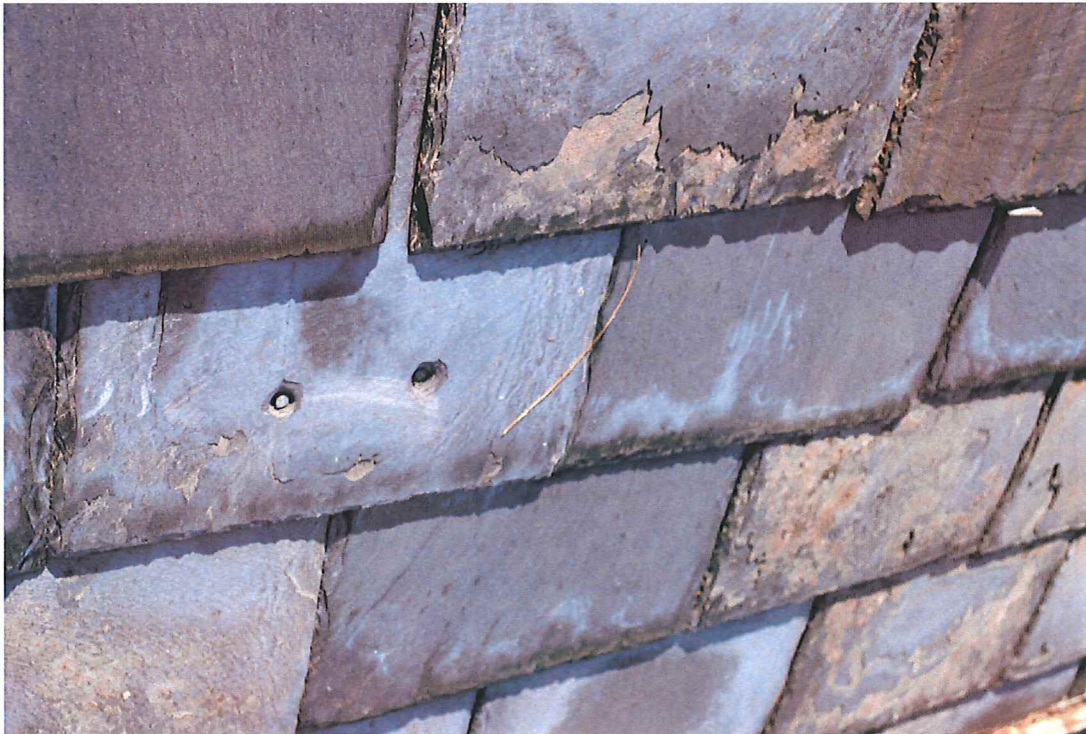
619 S. Lee Street image 5.

Here we see an example of poor quality repair work and yet another nail head push thru. The repair tiles are, Vermont Black held in place with copper strips and calk. Also the area around the newer tiles has been calked rather than replacing the broken/split slate.

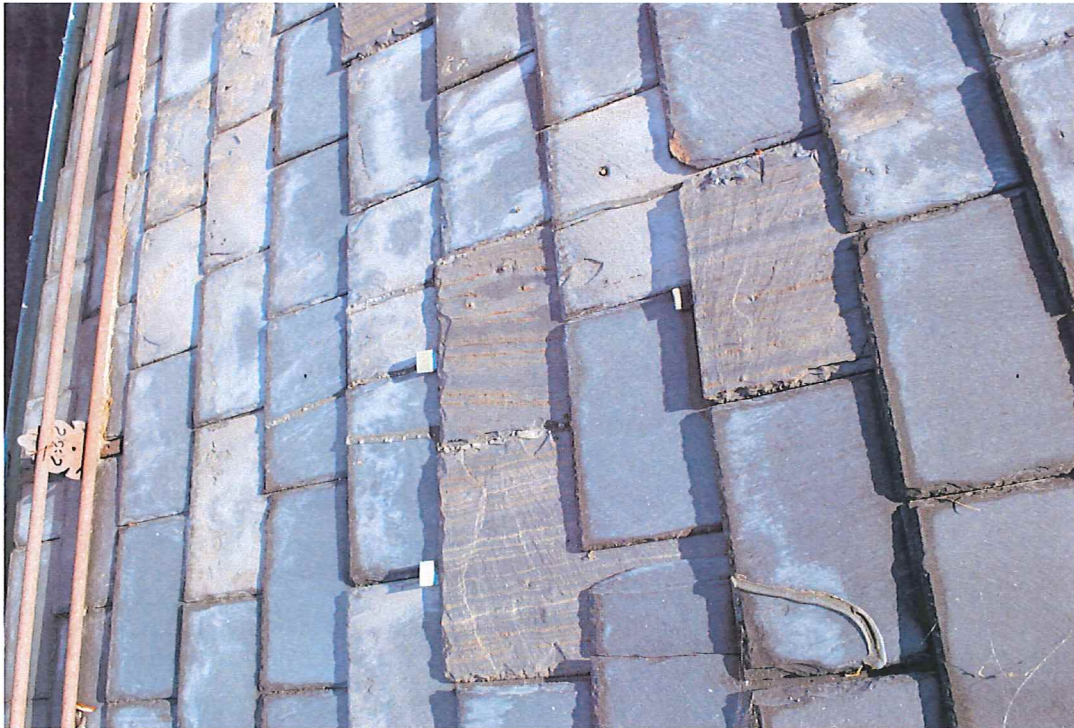
619 S. Lee Street image 6.

The dormer flashings and copper valleys have been worn thin and are now showing signs of water penetration on the inside of the house. The valleys at the top of the dormers were repaired some time ago with Tar. In addition the dormer ridges have been tarred and the last row of slate has exposed nails all along its length.

The copper flashing should be replaced with 20oz red cold rolled copper for the valleys and step flashings, with 16oz red cold rolled copper for the counter flashings.

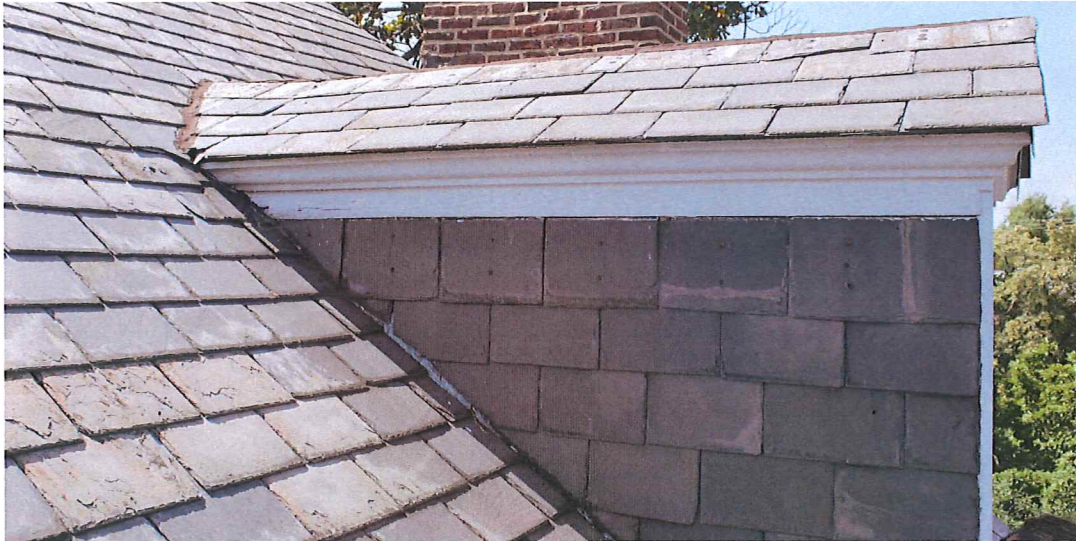
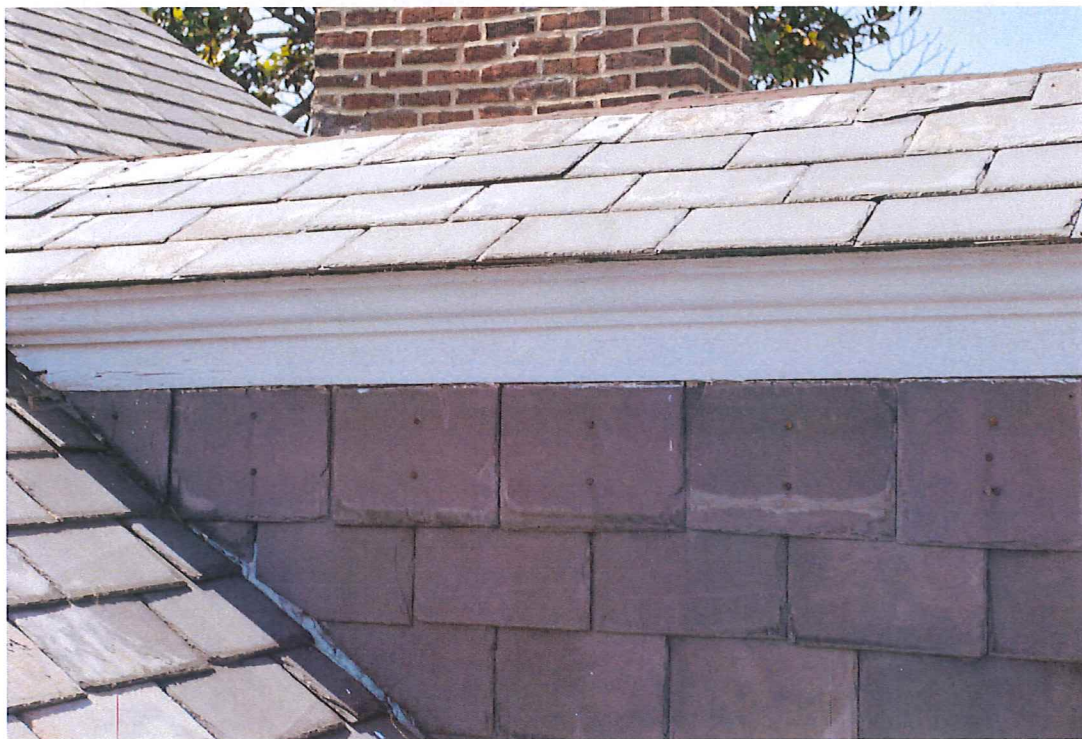
619 S. Lee Street images 7 & 8.

The flashing around the main roof chimneys has been tarred and calked in an attempt to prevent leaks. The street side chimney has been sealed from the inside around roof level with expanding foam. The foam is clearly visible where it has worked its way out from under the chimney flashing and even from under the slate.

The chimneys should be removed down to the roof line and rebuilt. Proper thru flashings should be installed. The thru flashing and counter flashing should be of 16oz red cold rolled copper with 20oz step flashing. The flue liner should also be replaced. The cap should be poured concrete wrapped entirely in copper with pitch pockets around the flues. The HI-Hat cover should be reused if possible or replaced with a similar cover. ~~The brick should then be treated with a breathable sealer such as, "Klear Treat Water Repellant" from Chargar Corporation; 299 Welton Street; Hamden, CT 06517 Tel: (203) 562-9948~~
