CITY OF ALEXANDRIA
HISTORIC PRESERVATION OFFICE
APPLICATION FOR BAR ADMINISTRATIVE
APPROVAL
APRIL 24, 2018

REPAIRS TO THE HISTORIC MAIN HOUSE
619 S LEE ST.
ALEXANDRIA, VA

BAR2018-00198

January, 10th, 2018

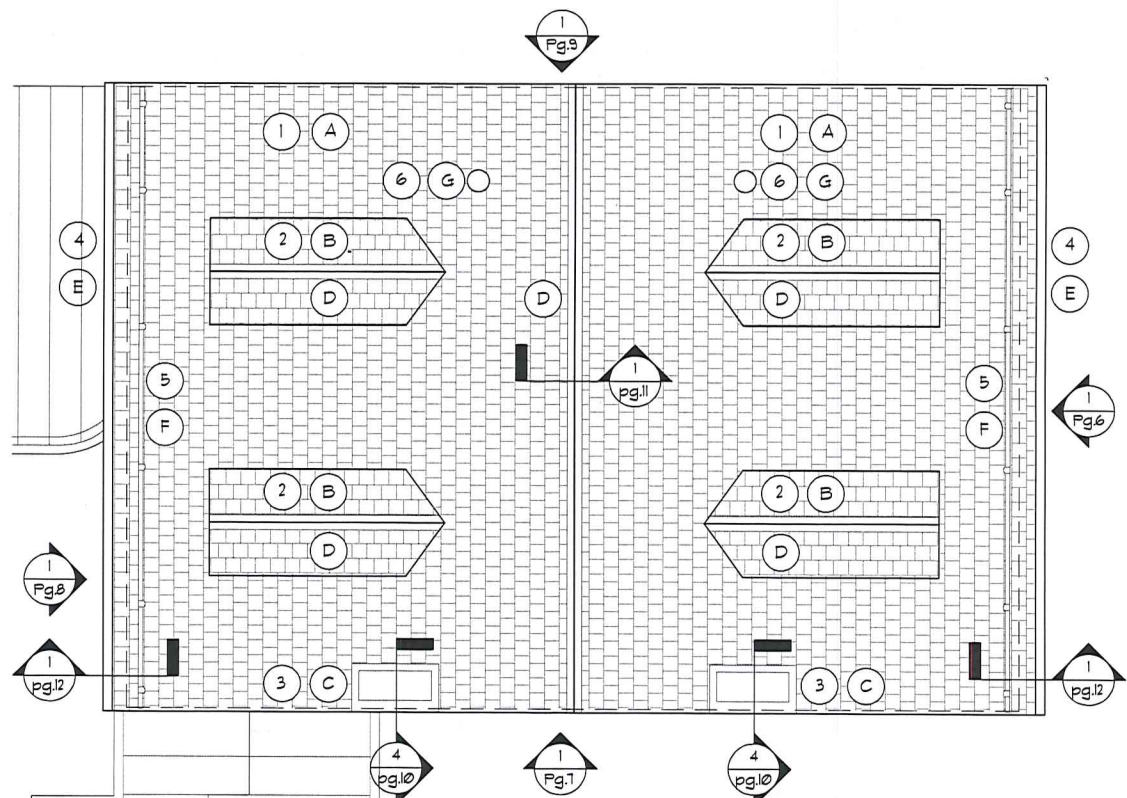
① ROOF PLAN REPAIRS
SCALE: 3/16" = 1'-0"

- ① REMOVE EXISTING SLATE ROOF TILES & COPPER FLASHINGS - REF ROOF REPORT
- ② REMOVE EXISTING SLATE @ DORMER ROOF & WALLS. - REF ROOF REPORT
- ③ DISMANTLE EXIST. CHIMNEY TO TOP OF ROOF. SALVAGE ALL BRICK FOR REUSE - REF ROOF REPORT, CHIMNEY ASSESSMENT & NARRATIVE
- ④ REMOVE EXISTING COPPER GUTTERS - REF ROOF REPORT
- ⑤ REMOVE EXISTING SNOW GUARDS - REF ROOF REPORT
- ⑥ REMOVE EXISTING PIPE FLASHING
- ⑦ REMOVE WINDOW SASHES FOR REPAIR - REF NARRATIVE, TYP @ DORMERS
- ⑧ REMOVE WD TRIM AS REQ'D TO INSTALL COPPER FLASHING @ SLATE DORMER WALLS.
- ⑨ REMOVE EXISTING COPPER RAKE TRIM - REF NARRATIVE

- Ⓐ NEW SLATE ROOF & ASSOC. COPPER FLASHINGS & DRIP EDGE - REF ROOF REPORT & DETAILS PG. 11
- Ⓑ NEW SLATE @ DORMER ROOF & WALLS - REF ROOF REPORT & DETAILS PG. 11
- Ⓒ REBUILD CHIMNEY W/ NEW REGLET-TYPE FLASHING - REF NARRATIVE, CHIMNEY ASSESSMENT & DETAILS PG. 10
- Ⓓ NEW COPPER RIDGE CAP - REF ROOF REPORT & DETAIL PG. 11
- Ⓔ NEW COPPER GUTTER - REF ROOF REPORT & DETAILS PG. 12
- Ⓕ NEW BRASS SNOW GUARDS - REF ROOF REPORT & DETAILS PG. 12
- Ⓖ NEW COPPER PIPE FLASHING - REF ROOF REPORT & DETAIL PG. 12
- Ⓗ REPAIR WD SILLS AS REQ'D. PROVIDE NEW COPPER FLASHING TO COVER SILLS
- Ⓙ NEW COPPER GUTTER OUTLET - REF ROOF REPORT & DETAILS PG. 12
- Ⓚ NEW 5" ROUND COPPER DOWNSPOUT AND BRACKET - REF ROOF REPORT & DETAILS PG. 12
- Ⓛ NEW PAINTED WOOD RAKE TRIM TO REPLACE COPPER - REF PG. 11

- Ⓜ PERFORM BRICK POINTING AS REQ'D BASED ON APVD MATERIALS & METHODS - REF NARRATIVE
- Ⓝ REPAIR / REPLACE EXISTING STONE SILL / HEADER BASED ON APVD MATERIALS & METHODS - REF NARRATIVE

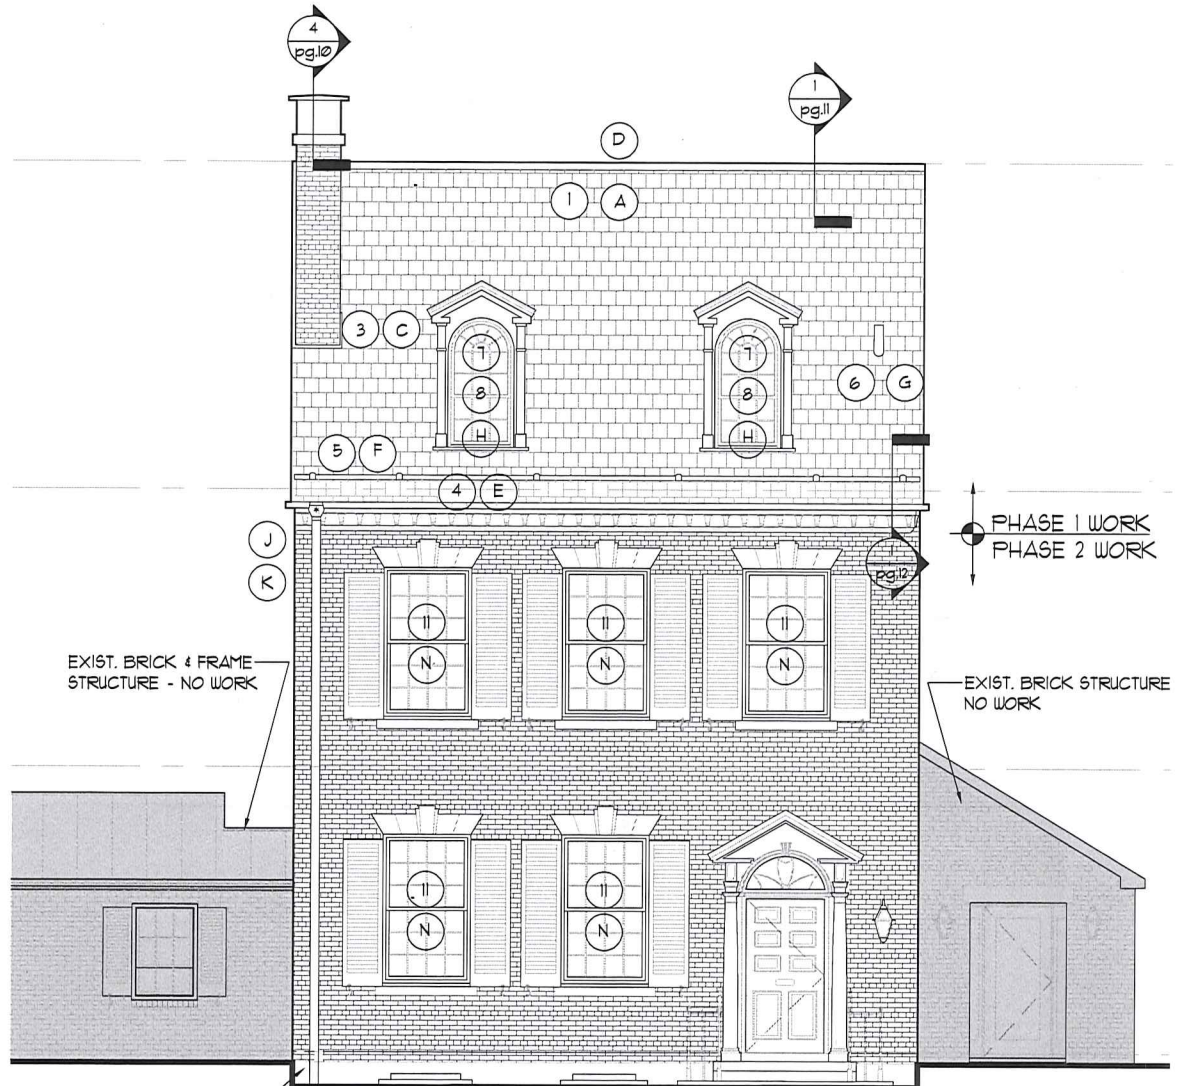
1 EAST ELEVATION REPAIRS
SCALE: 3/16" = 1'-0"

- 1 REMOVE EXISTING SLATE ROOF TILES & COPPER FLASHINGS - REF ROOF REPORT
- 2 REMOVE EXISTING SLATE @ DORMER ROOF & WALLS. - REF ROOF REPORT
- 3 DISMANTLE EXIST. CHIMNEY TO TOP OF ROOF. SALVAGE ALL BRICK FOR REUSE - REF ROOF REPORT, CHIMNEY ASSESSMENT & NARRATIVE
- 4 REMOVE EXISTING COPPER GUTTERS - REF ROOF REPORT
- 5 REMOVE EXISTING SNOW GUARDS - REF ROOF REPORT
- 6 REMOVE EXISTING PIPE FLASHING
- 7 REMOVE WINDOW SASHES FOR REPAIR - REF NARRATIVE, TYP @ DORMERS
- 8 REMOVE WD TRIM AS REQ'D TO INSTALL COPPER FLASHING @ SLATE DORMER WALLS.
- 9 REMOVE EXISTING COPPER RAKE TRIM - REF NARRATIVE

- M PERFORM BRICK POINTING AS REQ'D BASED ON APVD MATERIALS & METHODS - REF NARRATIVE
- N REPAIR / REPLACE EXISTING STONE SILL / HEADER BASED ON APVD MATERIALS & METHODS - REF NARRATIVE

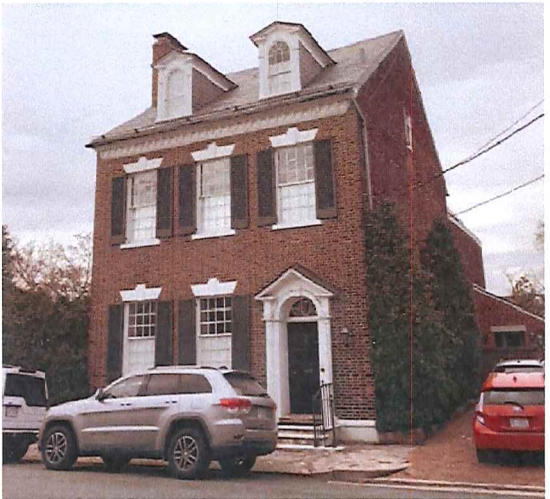
6 LEE ST. ELEVATION-EXISTING CONDITIONS
 NOT TO SCALE

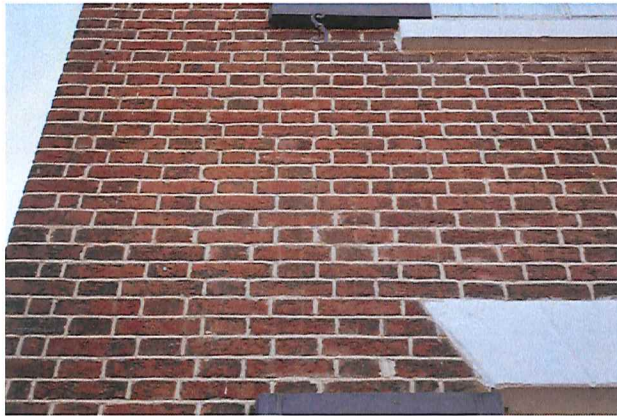
1 EAST ELEVATION (S. LEE ST) - NO WORK PROPOSED
NOT TO SCALE
